**Centre Region MS4 Partners**  
(College Township, Ferguson Township, Harris Township, Patton  
Township, The Pennsylvania State University – University Park Campus,  
Borough of State College)

**POLLUTANT REDUCTION PLAN**

November 15, 2017  
Last Revised November 22, 2019

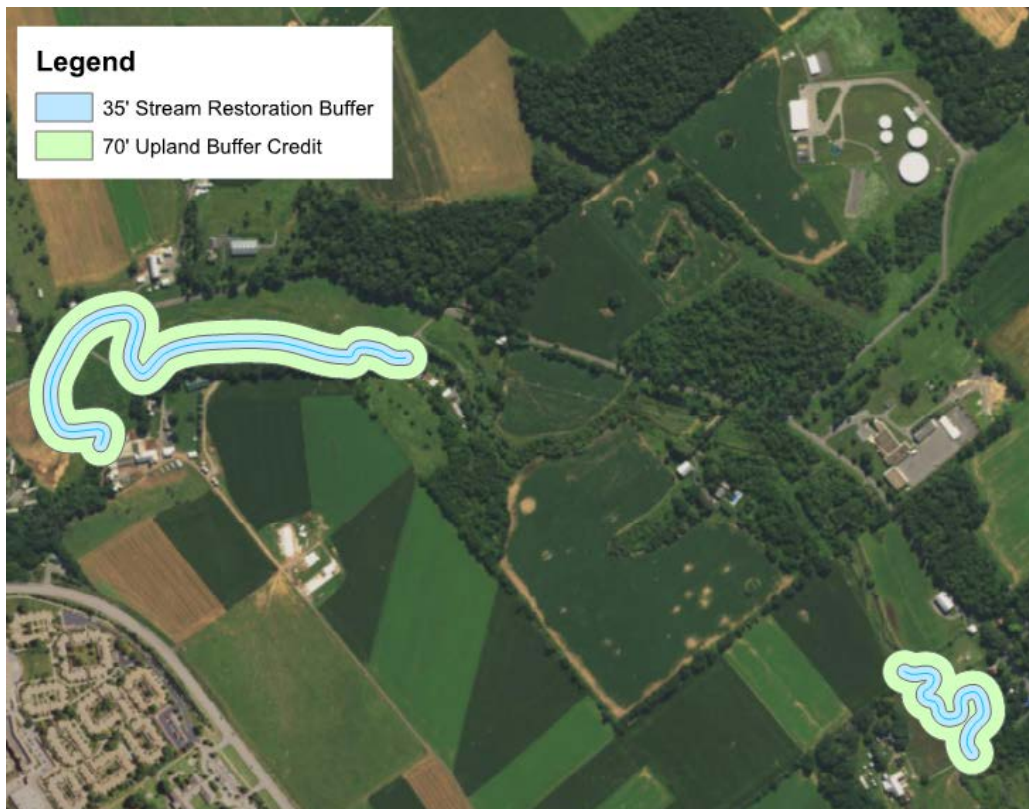
A 35-LF forested riparian buffer installed along a conservation easement in pastureland on the Meyer-Everhart Tract was considered (B1). For this analysis, it was assumed that dairy cattle will be restricted from accessing the stream. Credit generation computations were performed in accordance with protocols published in the *Recommendations of the Expert Panel to Reassess Removal Rates for Riparian Forests and Grass Buffers Best Management Practices* (Chesapeake Bay Program Forestry Working Group, October 2014).

*Figure 6. Location of Buffer and Adjacent Upland Credit Area.*

The land-use conversion analysis was performed in *MapShed* (GWLFE). The GWLFE output indicates that the current sediment load in the non-forested riparian buffer is 5,684 lb./yr. Given that forest buffers are effective at reducing the sediment load by 40%, the TSS load reduction for

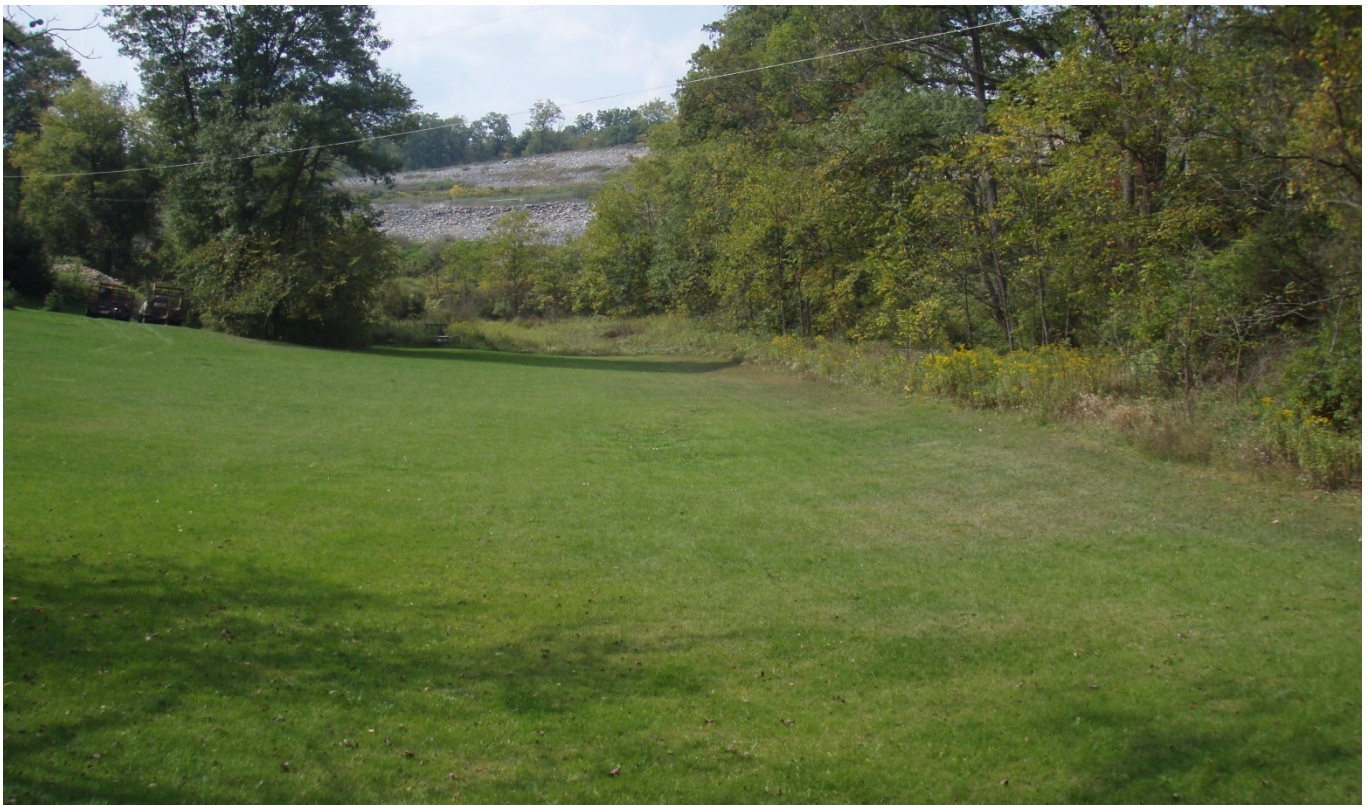
Figure 2. Big Hollow at Outlet (17.2 sq mi) has no Channel or Bed and Banks

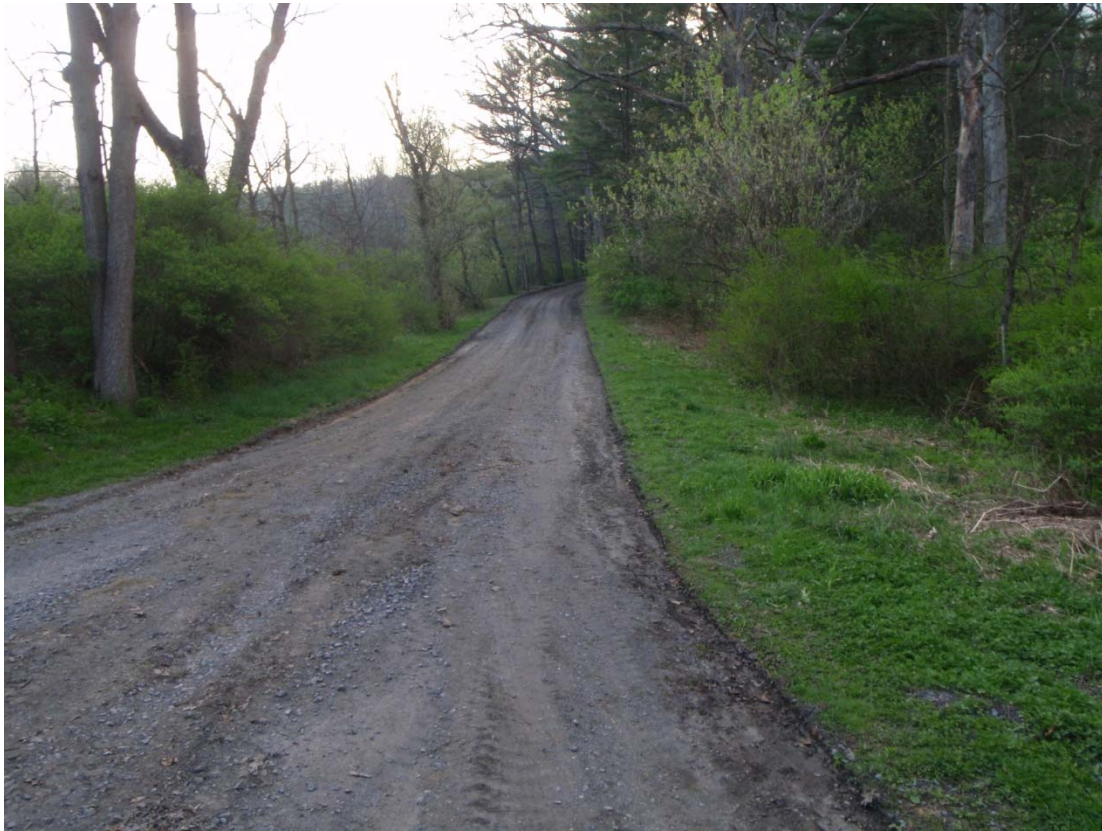
Figure 7. Photograph of Roadway Across Big Hollow with No Culvert (Gage 6 is located on the right side)

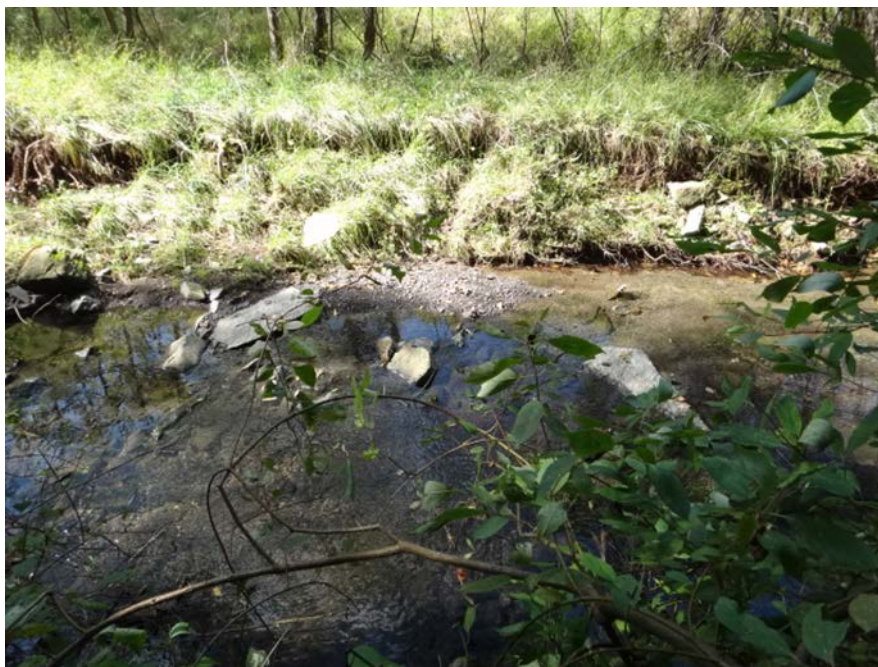
**Photo #2**

*Thompson Run –  
Actively eroding via  
bank slumping*

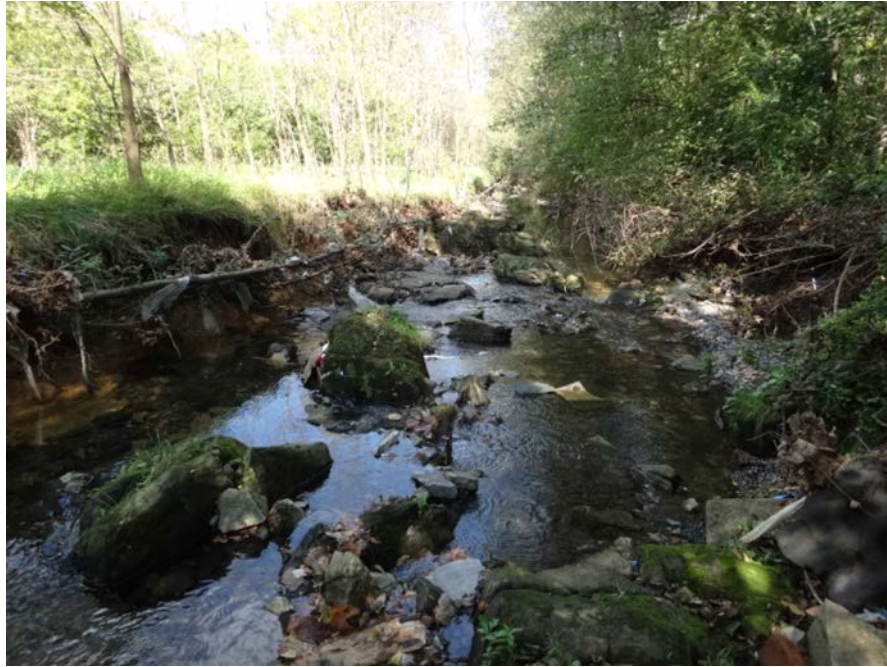
**Photo #3**

*Thompson Run – Deeply incised channel that is disconnected from the floodplain*

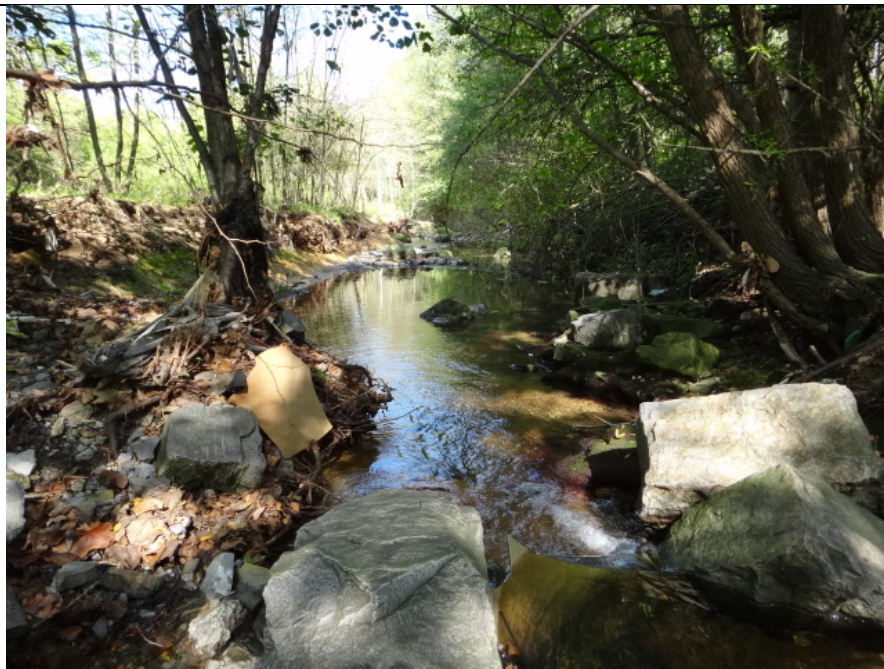
**Photo #4**

*Thompson Run – Deeply incised channel that is disconnected from the floodplain; limestone rip-rap illustrate failed attempts at stabilization*

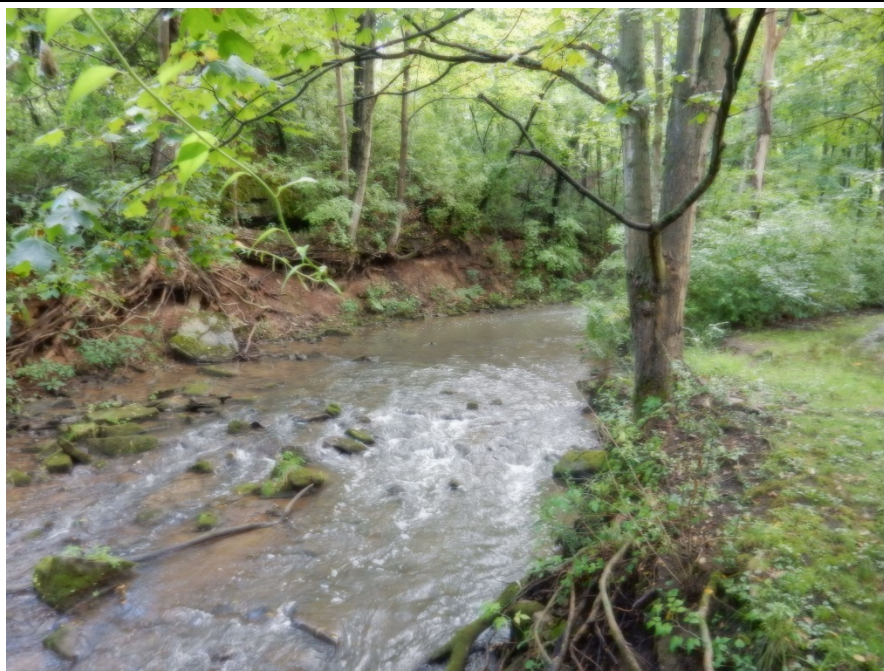
**Photo #5**

*Slab Cabin Run – At  
Slab Cabin Park – Bank  
erosion*

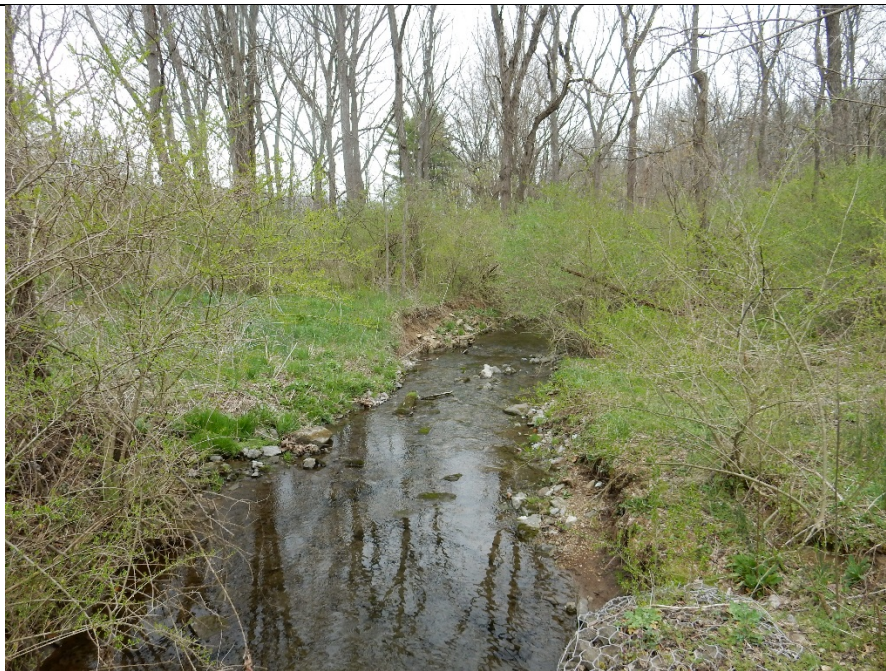
**Photo #8**

*Walnut Springs – Active  
bank erosion*

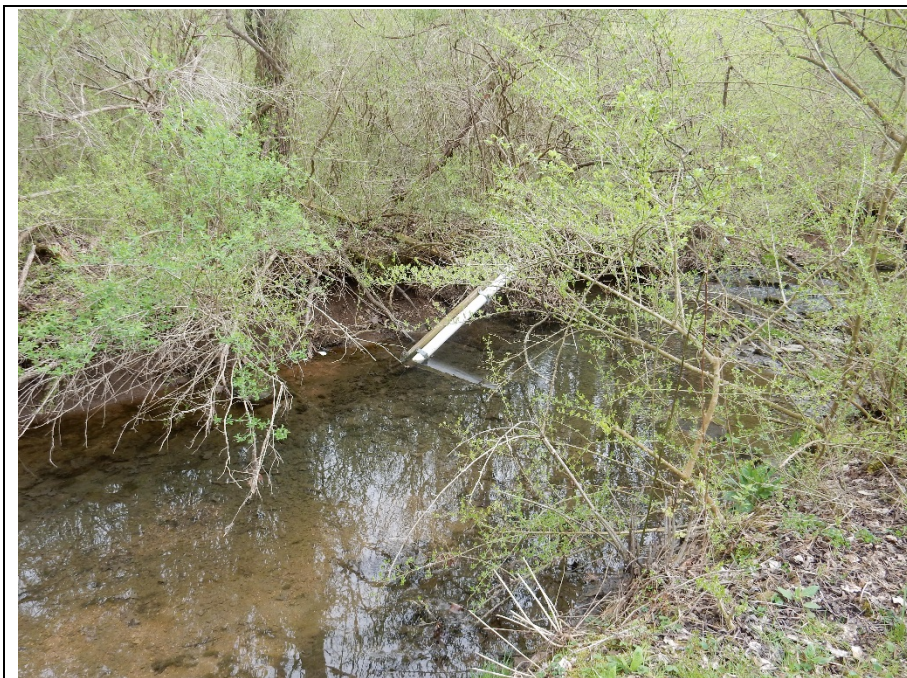
**Photo #9**

*Walnut Springs –  
Undercut banks*

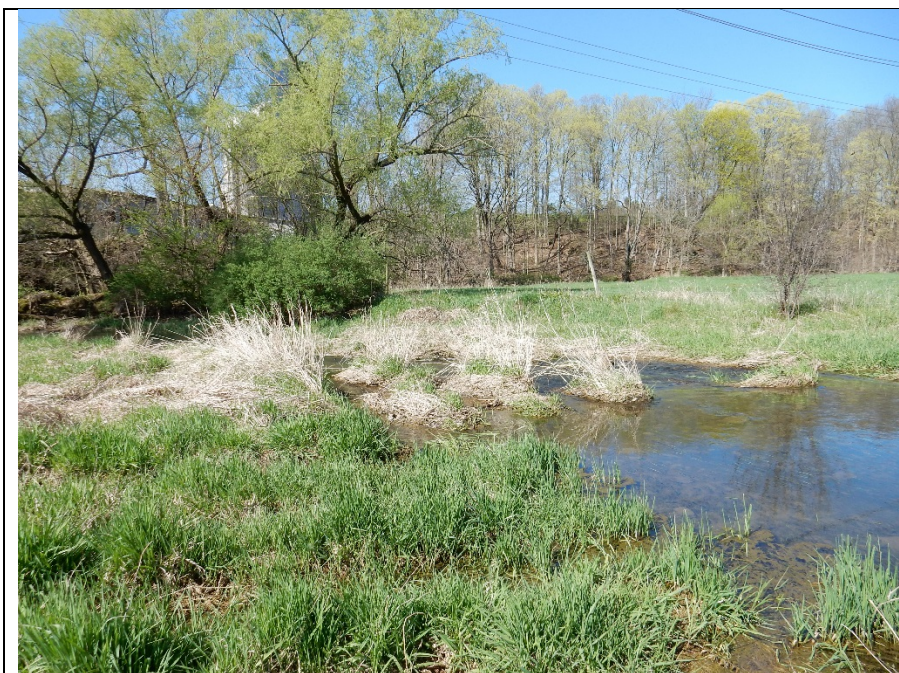
**Photo #14**

*Slab Cabin Run – Meyer Everhart Farm – Bank instability at a cattle-crossing*

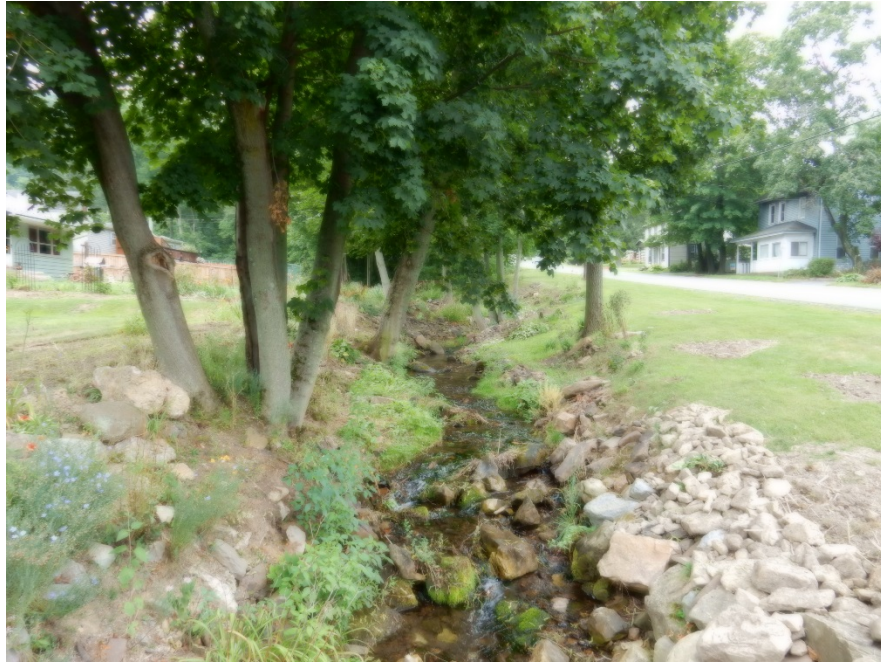
**Photo #17**

*Slab Cabin Run – Pine Grove Mills – Lack of Riparian buffer, incised channel, active erosion, attempts at stabilization have been made with rock*

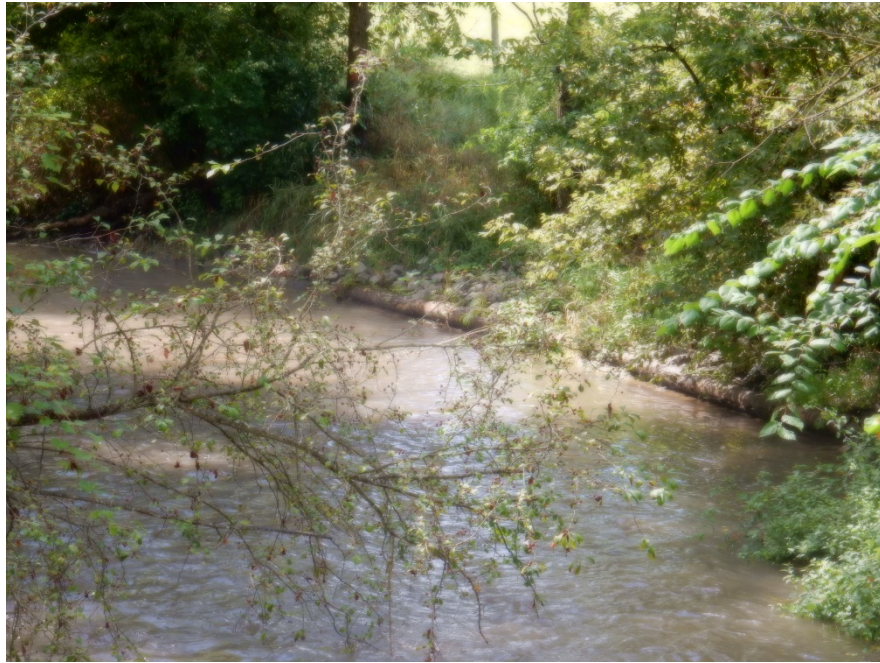
**Photo #19**

*Spring Creek – Spring  
Creek Park – Mud sill in  
lower restoration area*

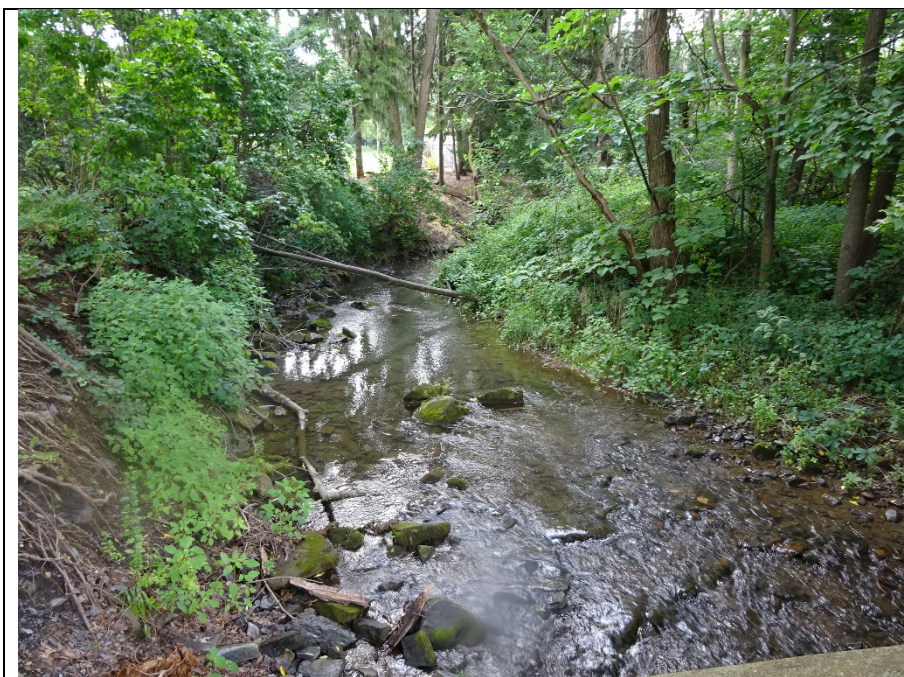
**Photo #24**

*Spring Creek – Pennsylvania Military Museum – Upstream of Boalsburg Pike, exposed roots on the right side of the bank illustrate bank erosion.*

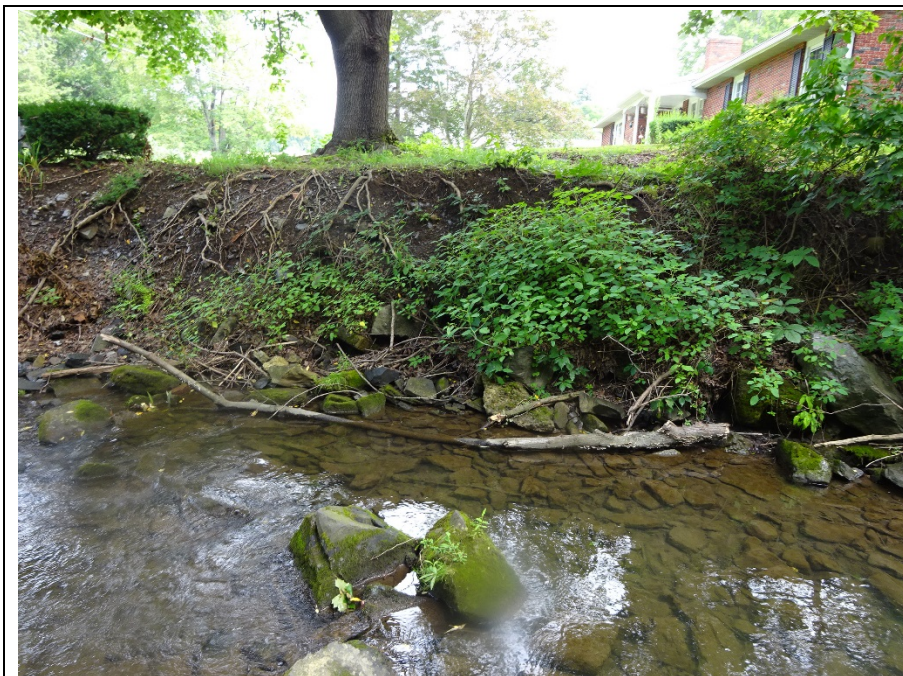
**Photo #25**

*Spring Creek –  
Upstream of Boalsburg  
Pike, steep and incised  
bank*

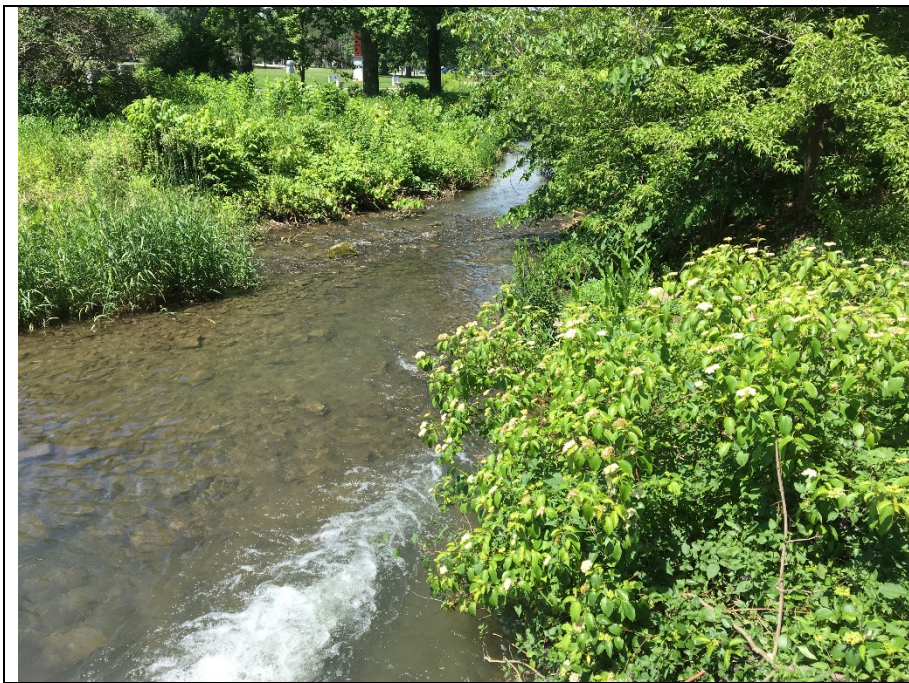
**Photo #28**

*Spring Creek –  
Pennsylvania Military  
Museum – Upstream of  
dam, incised stream*

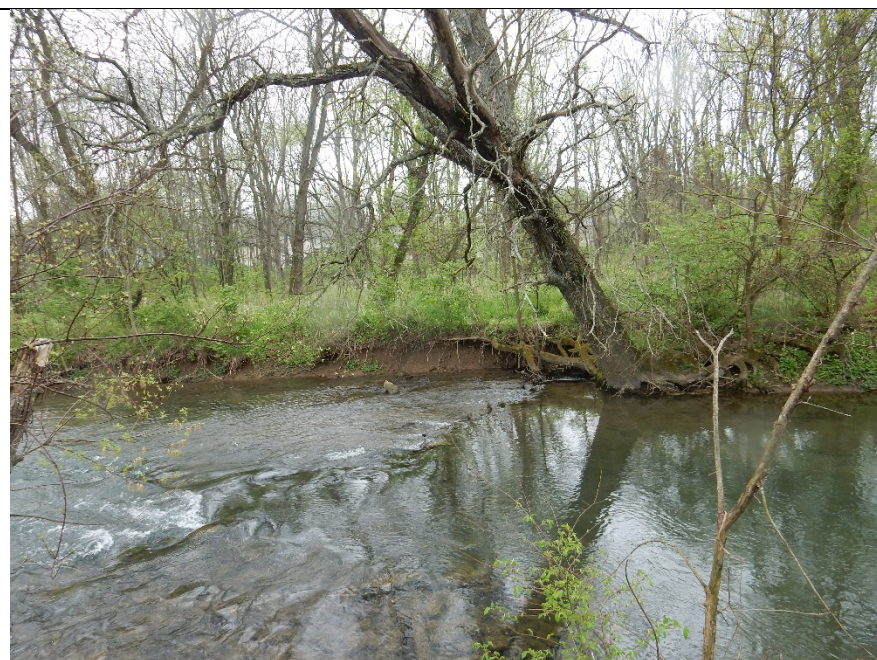
**Photo #32**

*Spring Creek – Spring  
Creek Estates – Actively  
eroding banks*

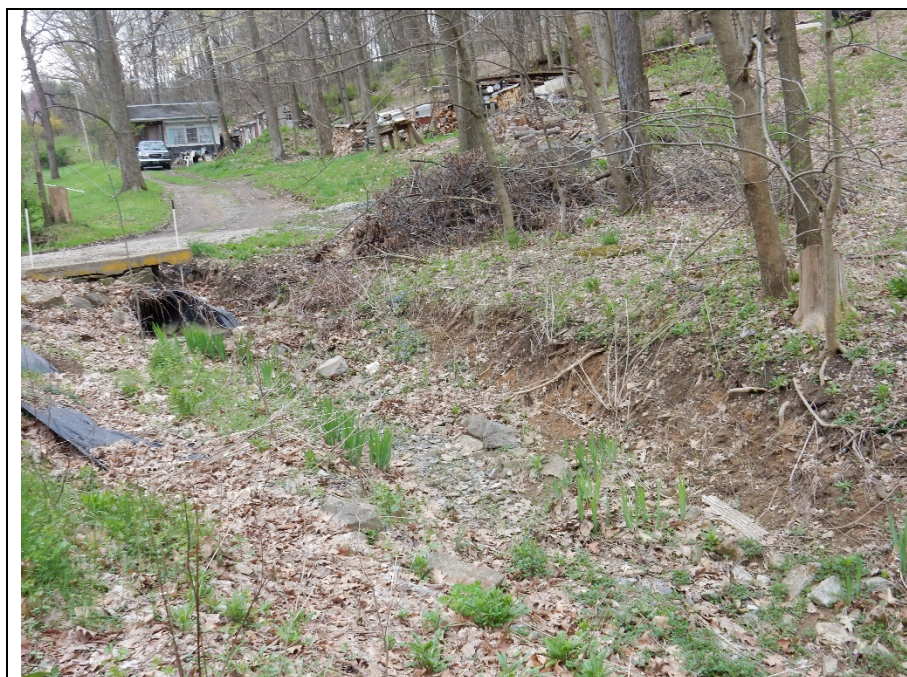
**Photo #36**

*UNT to Buffalo Run –  
Meeks Lane – Actively  
eroding channel*

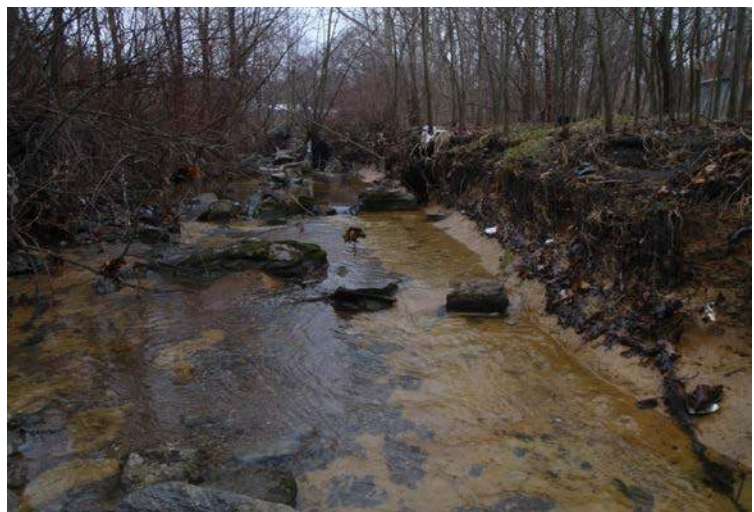
*Photograph 1. Duck pond channel following bioengineered stabilization*

The duck pond inflow channel has been actively eroding for the last two decades. As mentioned above, the floods of 1996 resulted in significant erosion to the streambank. Bioengineering efforts in 2002 failed to stabilize the stream reach. Based on surveyed channel geometry before the bioengineering project and current surveyed conditions and an assumed bulk density of  $2.0 \text{ g/cm}^3$ , it is estimated that bank is currently eroding at a rate of 102 lb./yr.

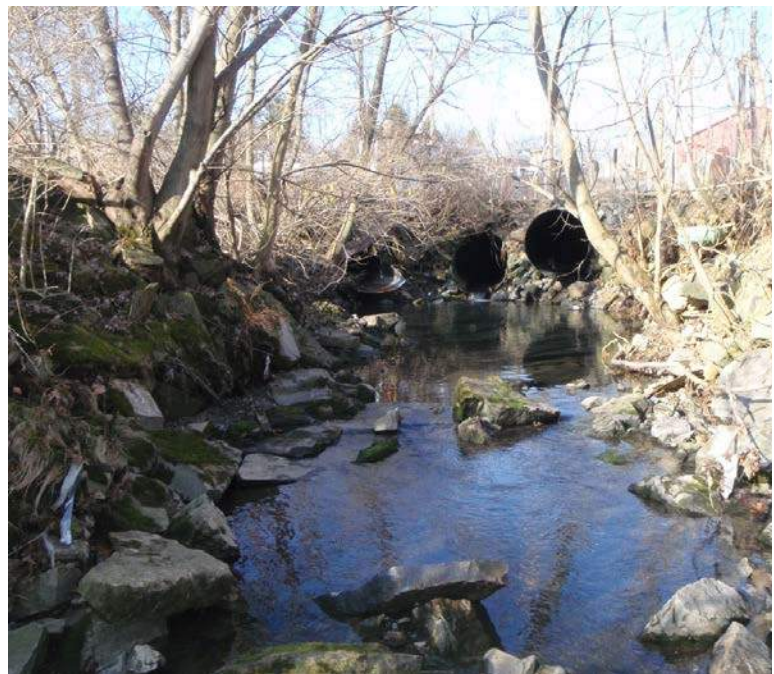
*Photograph 3. Stormwater discharge pipes at the beginning of the project reach*

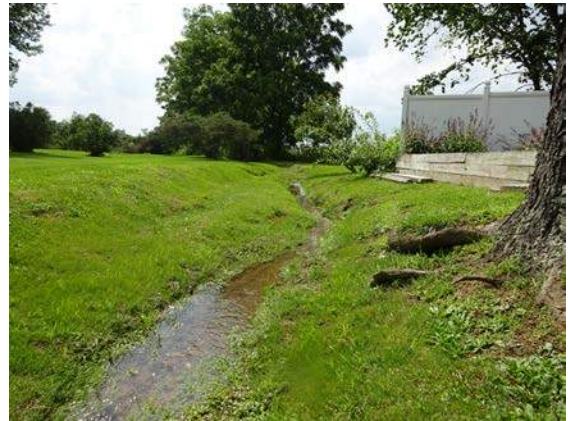
*Photograph 2. Sediment deposition in channel*

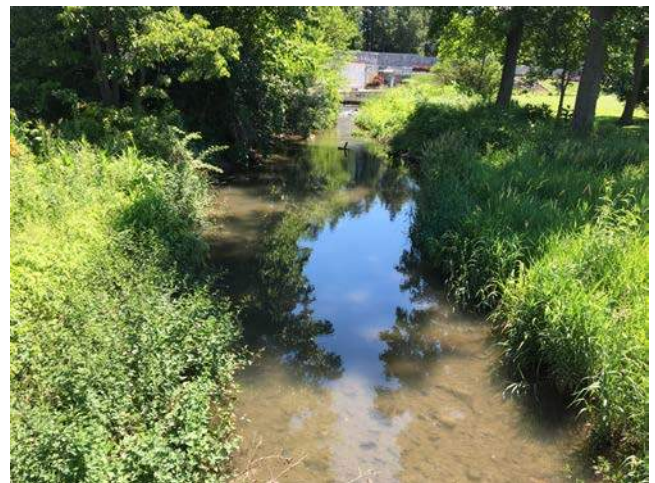
*Photograph 2. Incised steep cut banks with little floodplain connectivity (looking upstream)*

Active bank erosion and lack of floodplain connectivity are evidenced in **Photographs 1** through **3**. This project would be a continuation of the restoration project previously constructed immediately downstream.

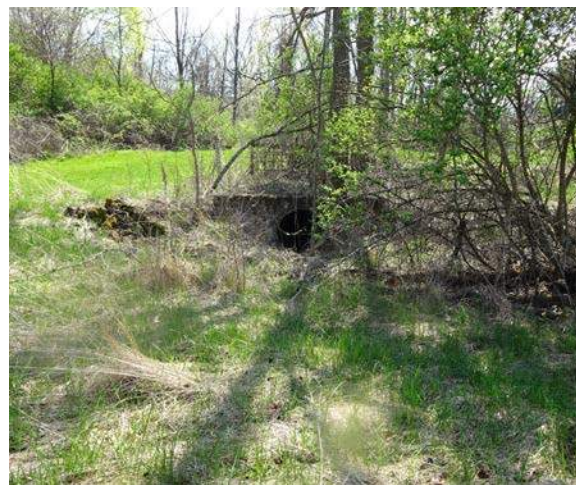
This project involves retrofitting a 1.7-acre stormwater management basin in Willowbrook Estates to include a runoff reduction function. The existing basin, illustrated in **Photograph 1**, was originally constructed in the mid 1980's to provide peak runoff control from the 50-acre subdivision. The basin covers approximately 1.7 acres and captures runoff from approximately 90% of the subdivision. The basin is currently vegetated with meadow grasses and wildflowers, and consists predominantly of Nolan Soils. Nolan soils (Hydrologic Soil Group B) are well drained, and have good infiltration characteristics.

*Photograph 2. Outlet structure for Willowbrook Basin (BMP A7)*

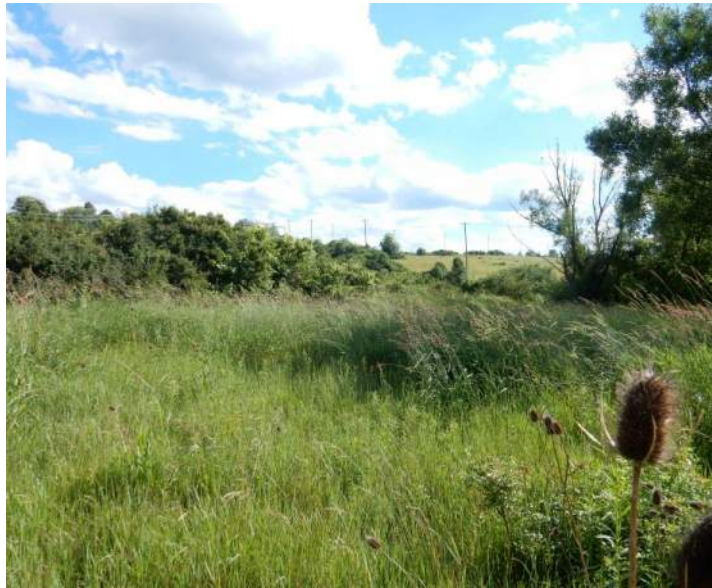
This project involves retrofitting a 1.38-acre stormwater management basin in Penn Hills to include a runoff reduction function. The existing basin, illustrated in **Photograph 1**, was originally constructed in the mid 1980's to provide peak runoff control from 70 acres of the subdivision. Approximately 17% of the drainage area (12 acres) is impervious. The basin is currently vegetated with meadow grasses and wildflowers and consists predominantly of Hagerstown and Opequon Soils. These soils (Hydrologic Soil Group B) are well drained and have good infiltration characteristics.

*Photograph 1. Penn Hills basin*

The Penn Hills basin has a surface area of 1.38 acres and drains 70 acres. Approximately 17% of the drainage area (12 acres) is impervious. The basin can be retrofit to have a 2.41 ac.-ft. runoff storage volume. Applying a conservative estimate for infiltration rate of 0.31 inches per hour, the stored runoff will be removed via infiltration in 72 hours. Entering the runoff storage volume of 2.41 ac.-ft. and an impervious area of 12 acres into the expert panel equation, a rainfall capture depth of 2.4 inches per impervious acre was computed.
